USAAVLABS TECHNICAL REPORT 69-90

**INVESTIGATION OF
CH-54A ELECTROSTATIC CHARGING
AND OF
ACTIVE ELECTROSTATIC DISCHARGER CAPABILITIES**

**U. S. ARMY AVIATION MATERIEL LABORATORIES
FORT EUSTIS, VIRGINIA**

**CONTRACT DAAJ02-69-C-0102
DYNASCIENCES CORPORATION
SCIENTIFIC SYSTEMS DIVISION
BLUE BELL, PENNSYLVANIA**

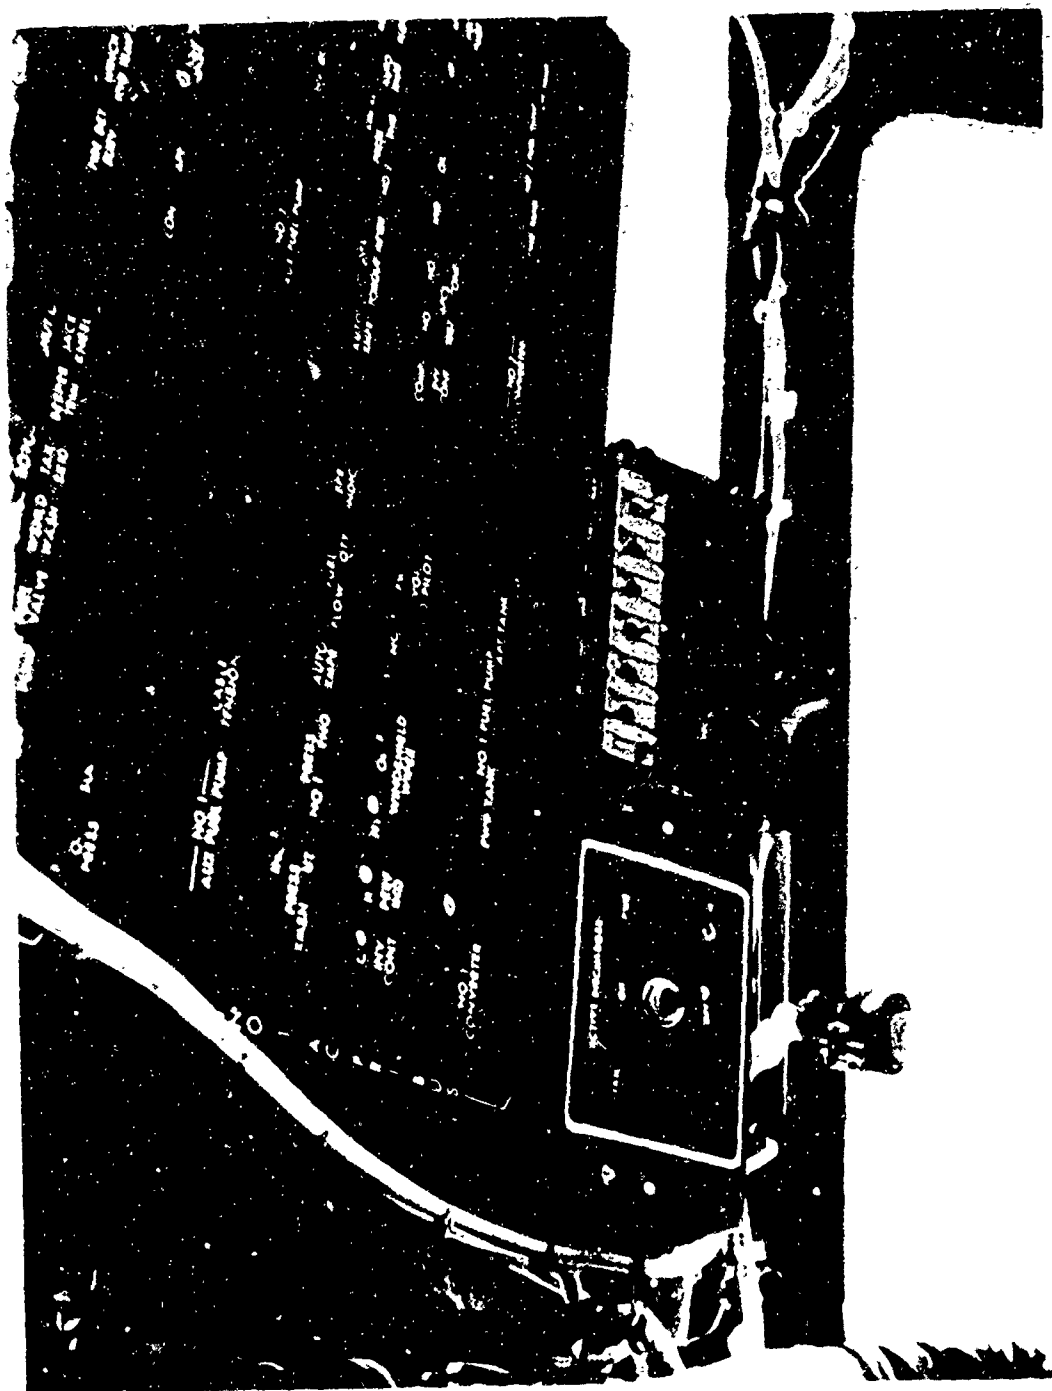
Figure 16. Tie-in With CH-54A Test Aircraft Electrical System.
